# SERVICE INFORMATION

Subject:

Water ingress through oil reservoir breather

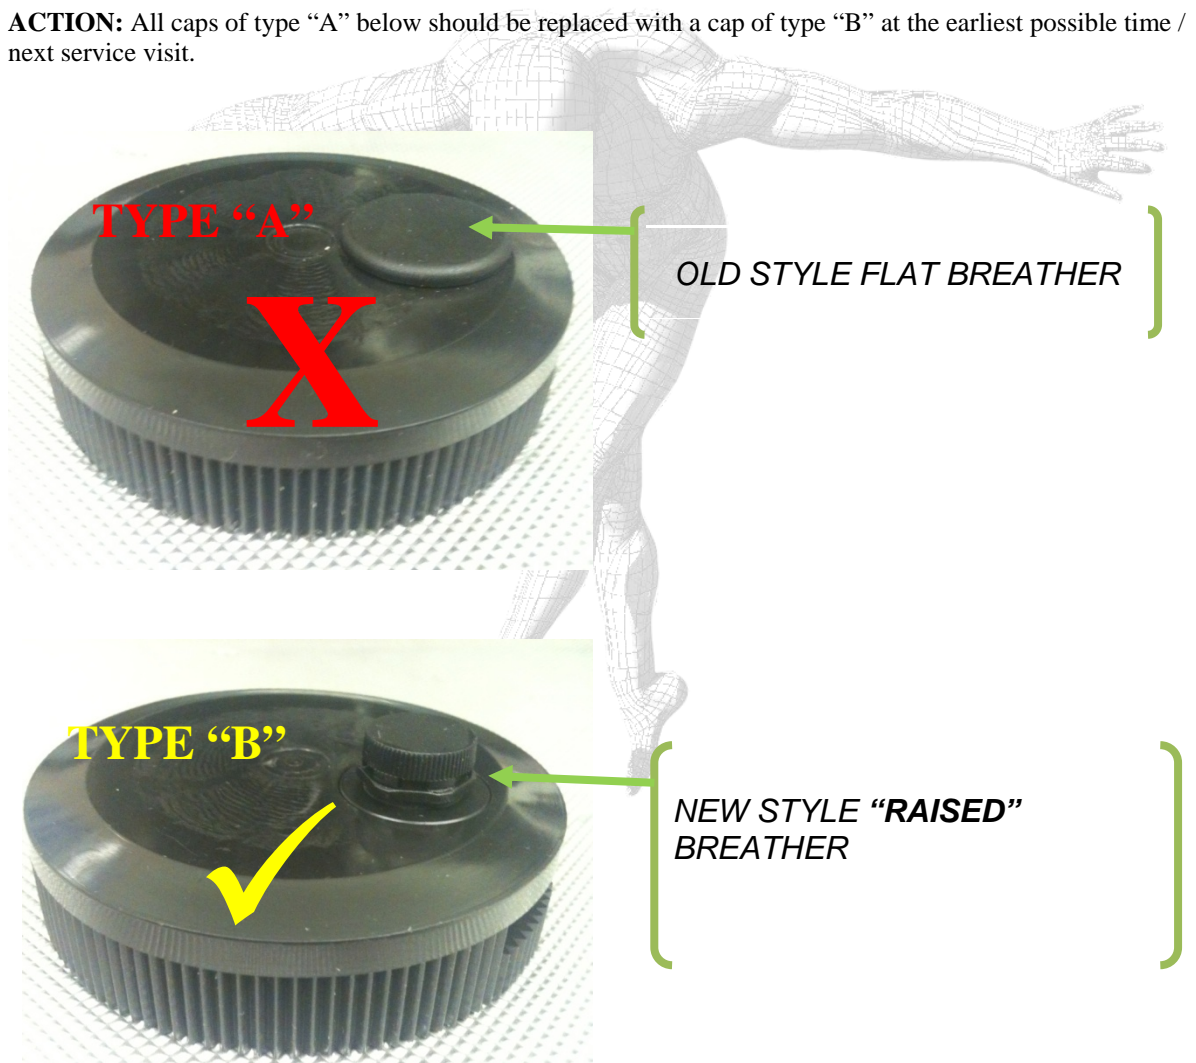
We have found that in certain conditions it is possible that water can leak into the oil reservoir which in turn causes the oil to turn milky.

**ACTION:** All caps of type "A" below should be replaced with a cap of type "B" at the earliest possible time / next service visit.
