Repair Manual Pumps

P100 / P120

P150 / P200 / P260

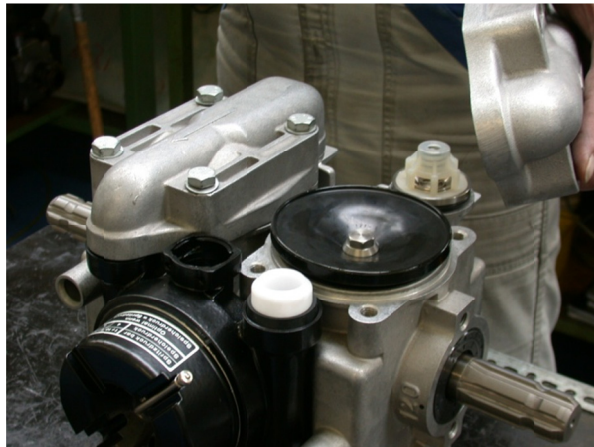
-Picture 1-

Disposal: Drain the oil, unbolt the valve cover/s and remove, check diaphragm (or diaphragms).
[Picture 1]

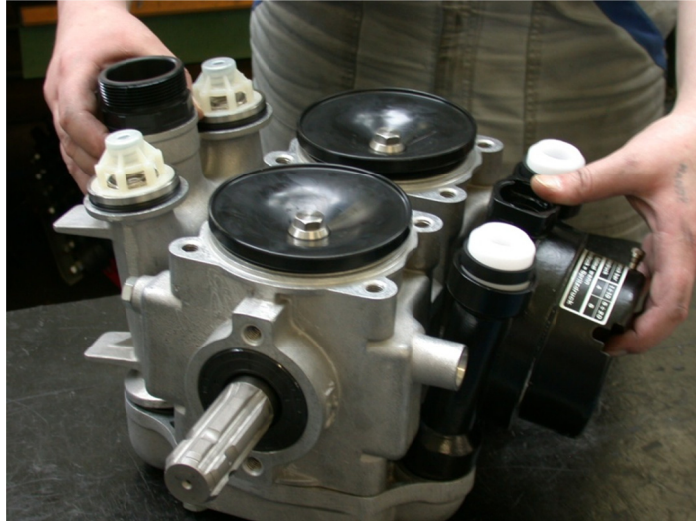
-Picture 3-

Disposal: Drain the oil, then unbolt the valve cover, test the O-Ring.
[Picture 3]

Take the suction valve and pressure accumulator from the seat, replace the damaged O-Ring and insert the valves again. Replace valve cover again, the bolts (M12) are to be hand tightened up to the spring washers and then tightened crosswise (tightening torques page 12). Test the drive shaft. Fill in with new oil, for oil type and quantity refer to the oil sticker.

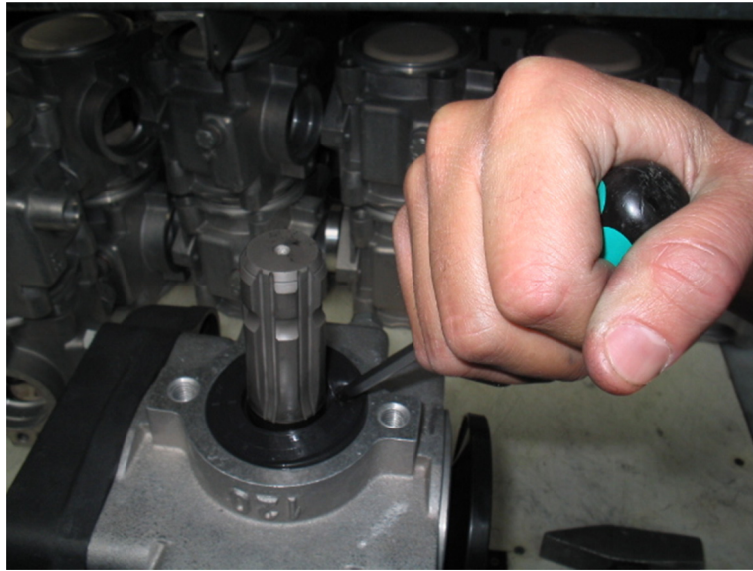
-Picture 4-

Disposal: Remove the damaged oil seal with a suitable tool, be careful not to damage the sealing surface [Picture 4].

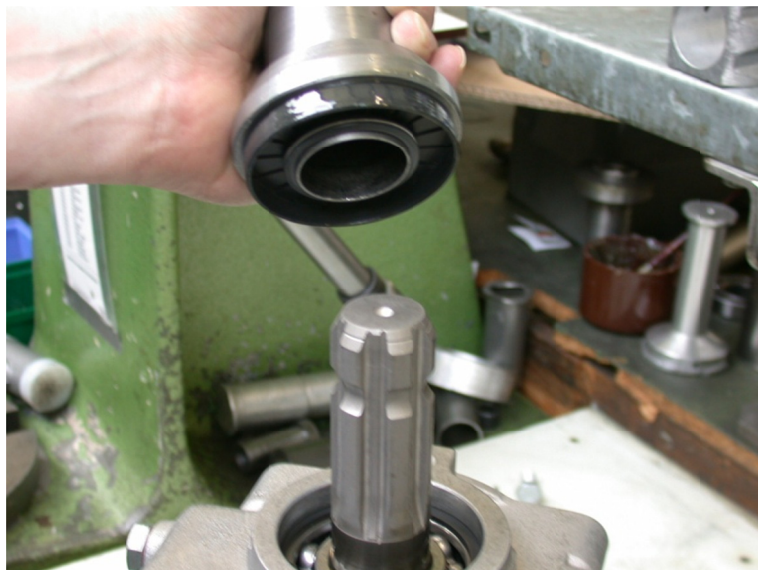
-Picture 5-

Grease a new shaft seal ring and mount it with mounting aid [Picture 5].

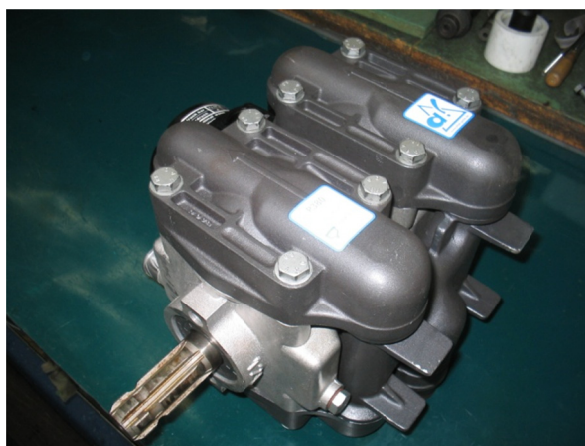
- Picture 7-

Set the Pump to the side in order to avoid leaking of oil in the engine block. [Picture 7]

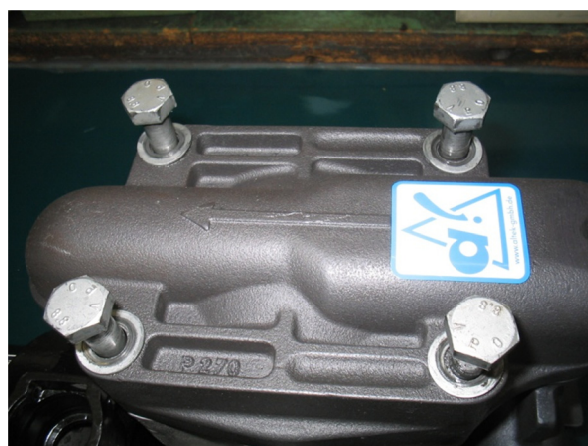
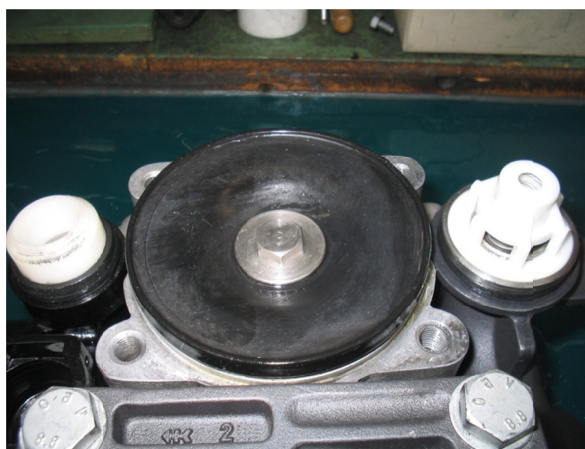
Bolt the valve cover off and lift it.
[Picture 8 und Picture 9]

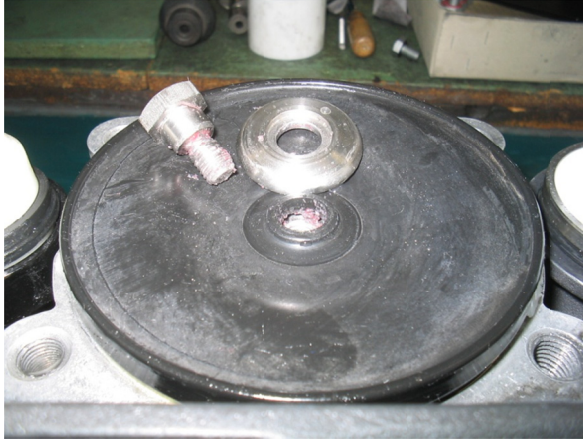
-Picture 11-

Remove diaphragm bolt and disc. [Picture 11]

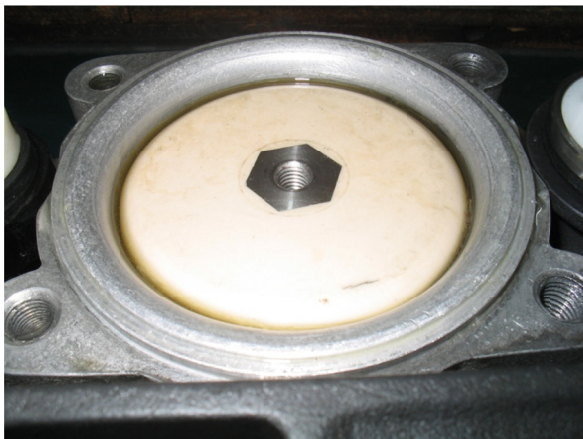
Remove diaphragm and kell ring. [Picture 12 und Picture 13]

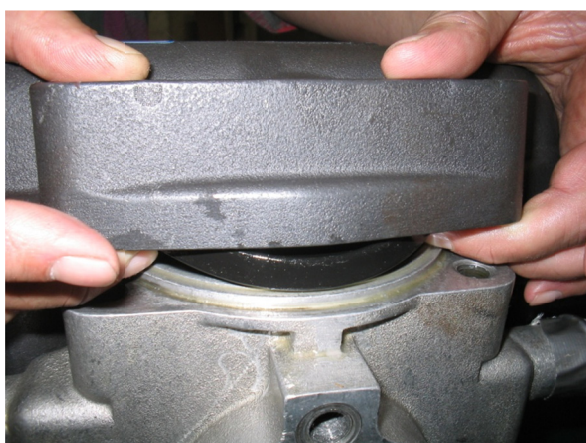
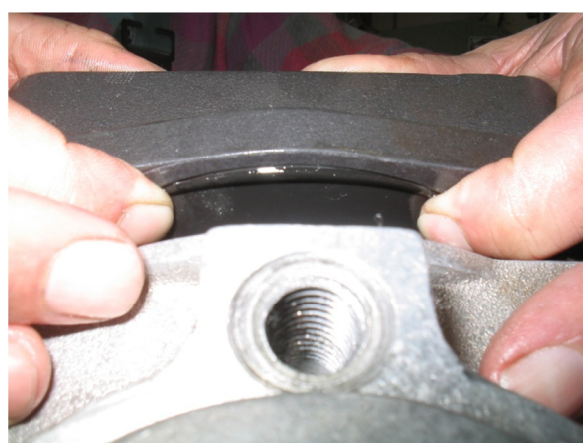
Caution: When putting in the valve covers, set the Diaphragm with the fingers on top of the valve cover in order to avoid crushing it. [Picture 17 und Picture 18]

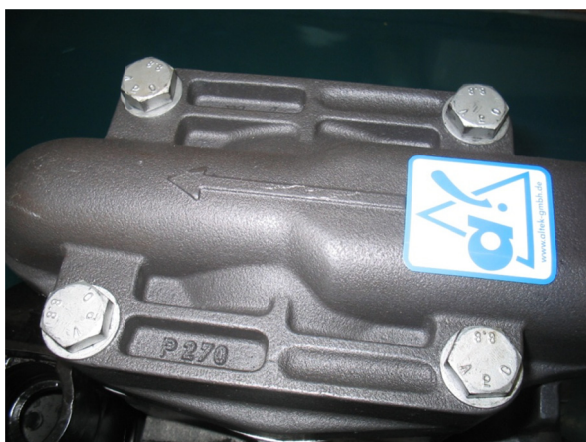
- Picture 19-

Replace bolts (M12) and valve covers with washers and tighten (Tightening torques Page 12). [Picture 19]
